# **INDOOR AIR QUALITY ASSESSMENT**

**Maria Hastings Elementary School  
2618 Massachusetts Avenue  
Lexington, MA 02421**

Prepared by:  
Massachusetts Department of Public Health  
Center for Environmental Health  
Emergency Response/Indoor Air Quality Program  
March 2007

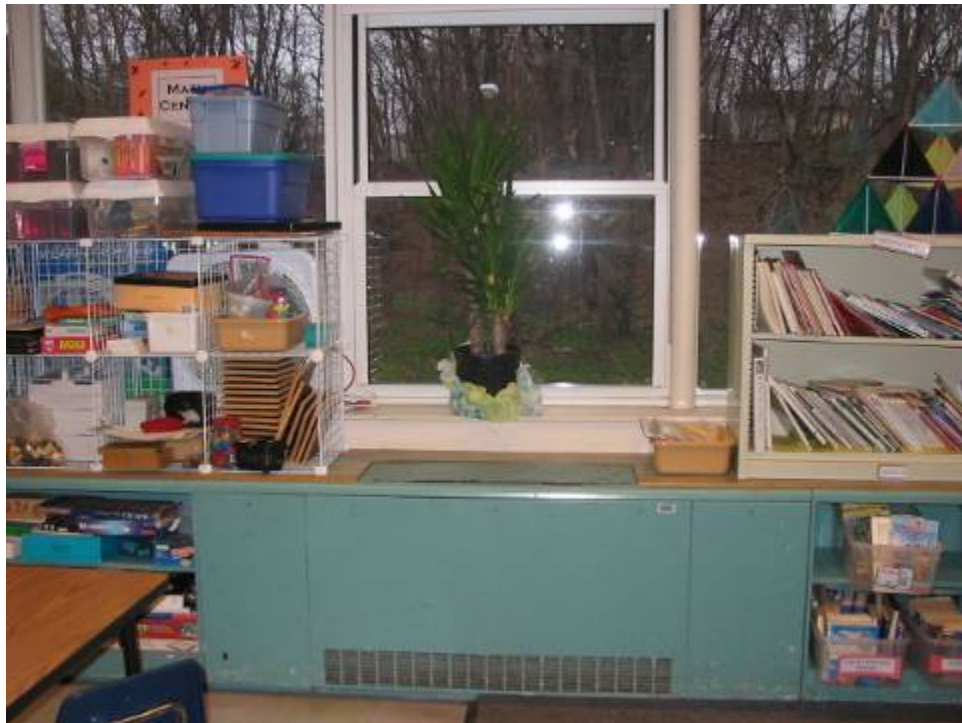
**Picture 1**

Fresh air for classrooms in the original building and 1960 addition is supplied by unit ventilator (univent) systems ([Figure 1](#), Picture 1). A univent draws air from outdoors through a fresh air intake located on the exterior wall of the building (Picture 2) and returns air through an air intake located at the base of the unit. Fresh and return air are mixed, filtered, heated and provided to classrooms through a diffuser located on the top of the unit. Obstructions to airflow, such as furniture located in front of and/or materials stored on univents, were observed in many

**Classroom univent**

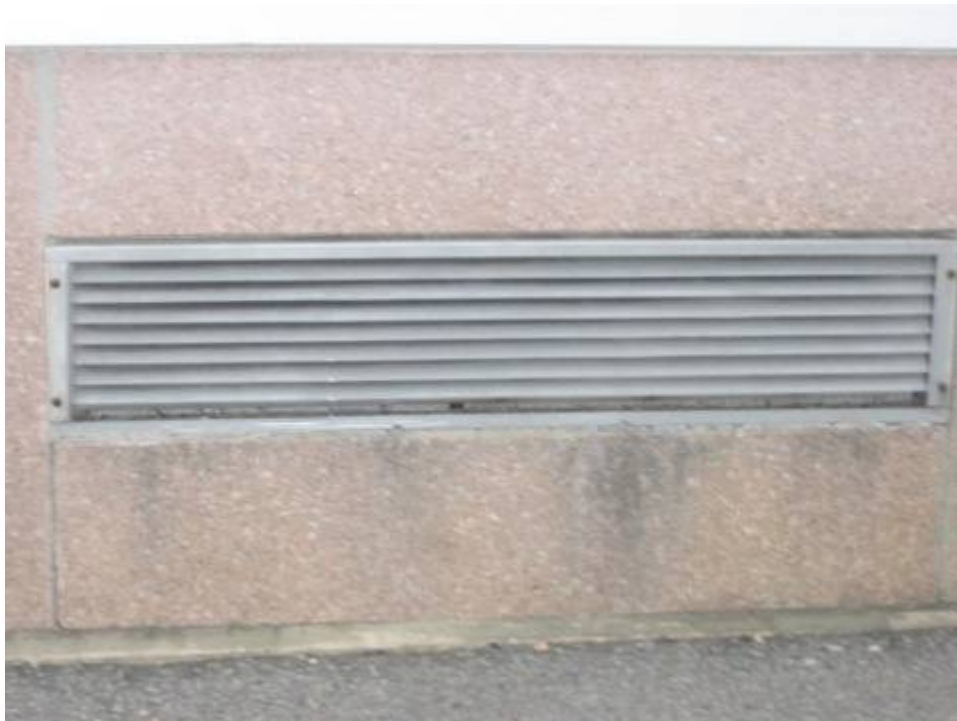
**Picture 2**

**Univent fresh air intake on building exterior**

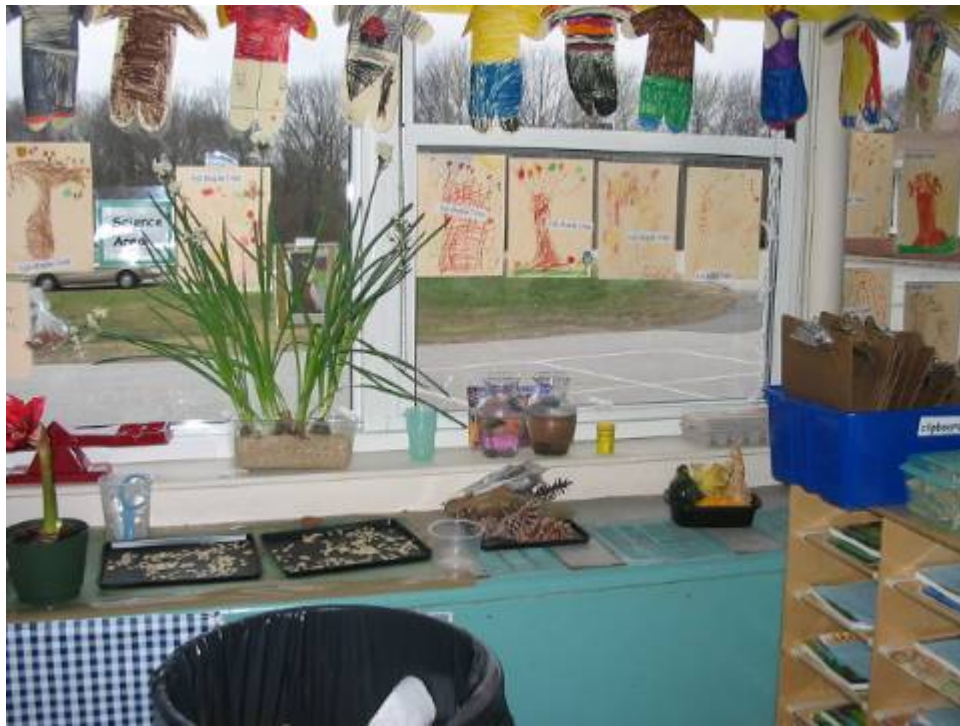
**Picture 3**

areas (Pictures 3 and 4). Some univents were not operating at the time of the assessment. In order for univents to provide fresh air as designed, intakes and returns must be free of obstructions and importantly, these units must be operating while rooms are occupied.

**Items placed on top of univent**

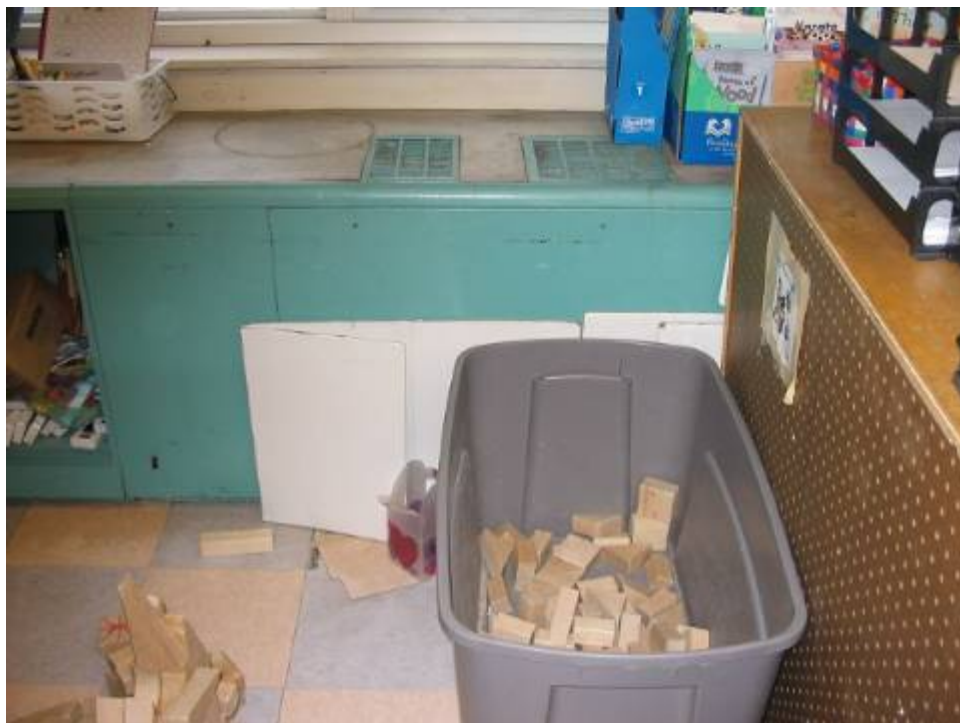
**Picture 4**

**Items placed in front of univent**

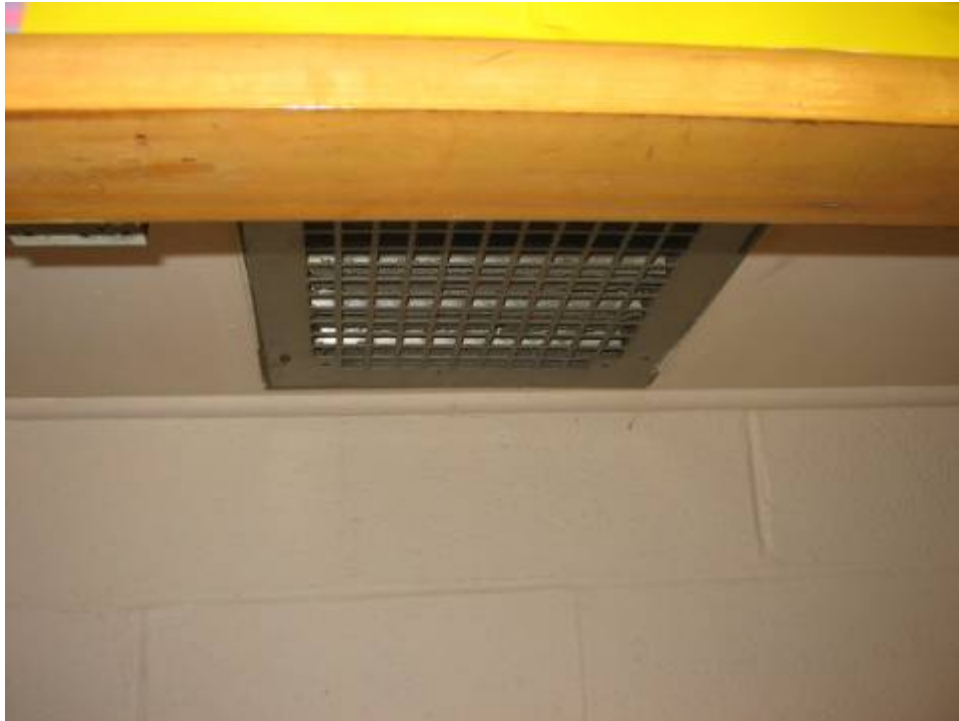
**Picture 5**

Mechanical exhaust ventilation for classrooms in the original building and the 1960 addition is provided by closet or wall-mounted exhaust vents (Pictures 5 and 6) ducted to rooftop exhaust fans. Some exhaust vents did not appear to be operating at the time of the assessment. It is important to note that the location of some exhaust vents can limit exhaust efficiency. In some classrooms, exhaust vents are located behind hallway doors (Picture 6). When classroom doors are open, exhaust vents are blocked. In addition, other blockages to exhaust (i.e., furniture or items placed in front) were noted. The effectiveness of exhaust vents to remove common environmental pollutants from classrooms becomes reduced when vents are blocked. As with univents, exhaust vents must be activated and remain free of obstructions in order to operate as designed.

**Closet exhaust in 1955 classroom**

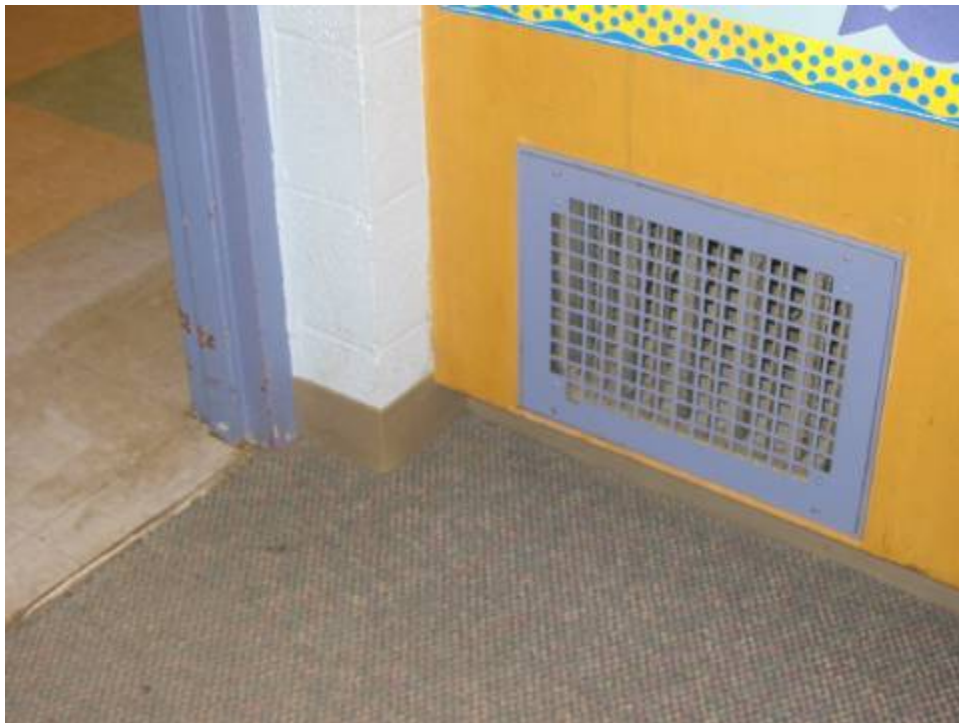
**Picture 6**

**Wall exhaust typical of 1955 and 1960 classrooms**

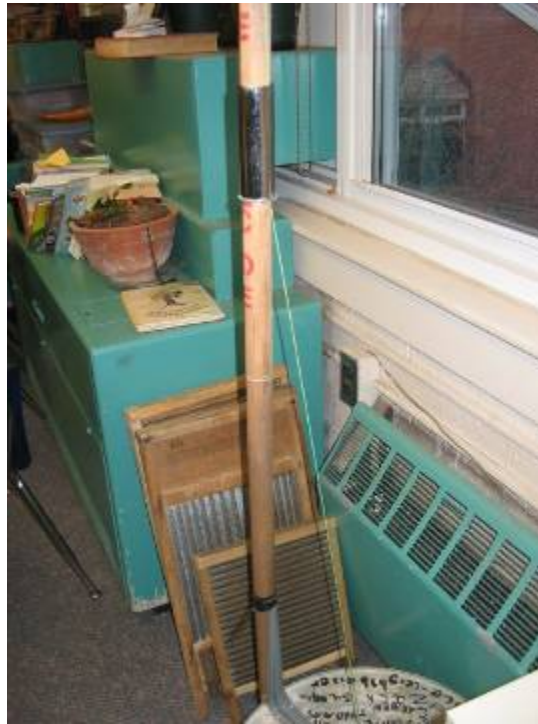
**Picture 7**

Exhaust ventilation for the music room is provided by a unit exhaust ventilator (Picture 7). A unit exhaust ventilator appears similar to a univent, but removes air from the classroom and exhausts it out of the building. This unit was operating weakly at the time of assessment.

**Unit exhaust ventilator in music room**

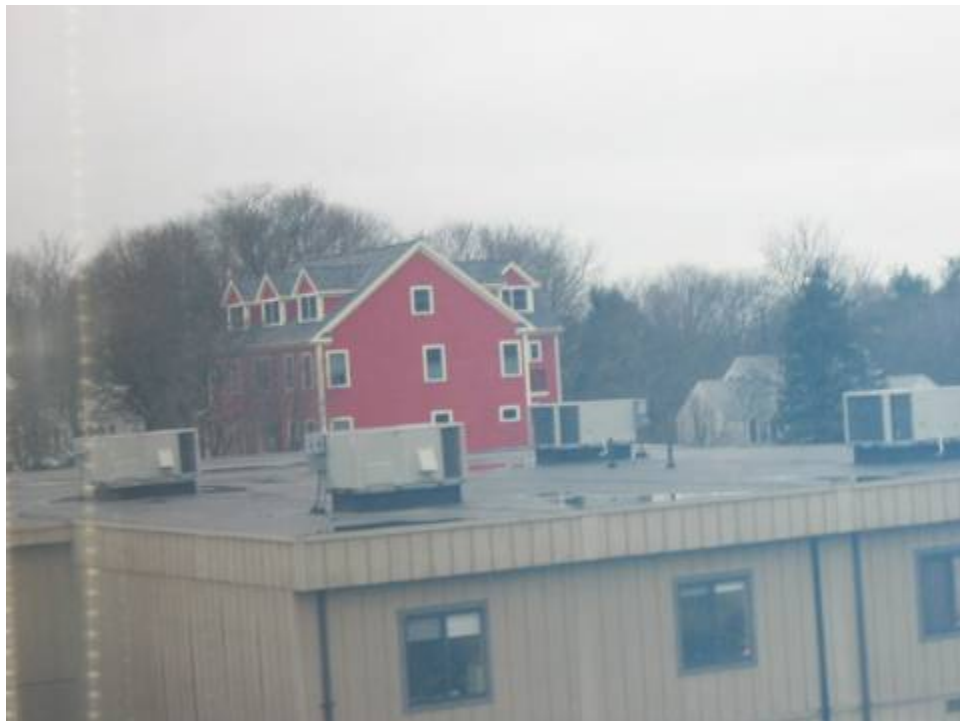
**Picture 8**

**AHUs for modular building, which houses classrooms 31 to 34**

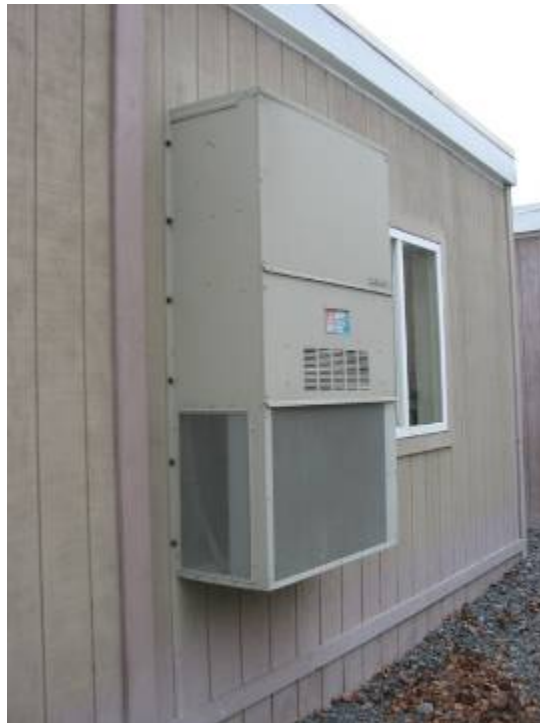
**Picture 9**

**AHU for a classroom in modular building, which houses classrooms 41 to 44**

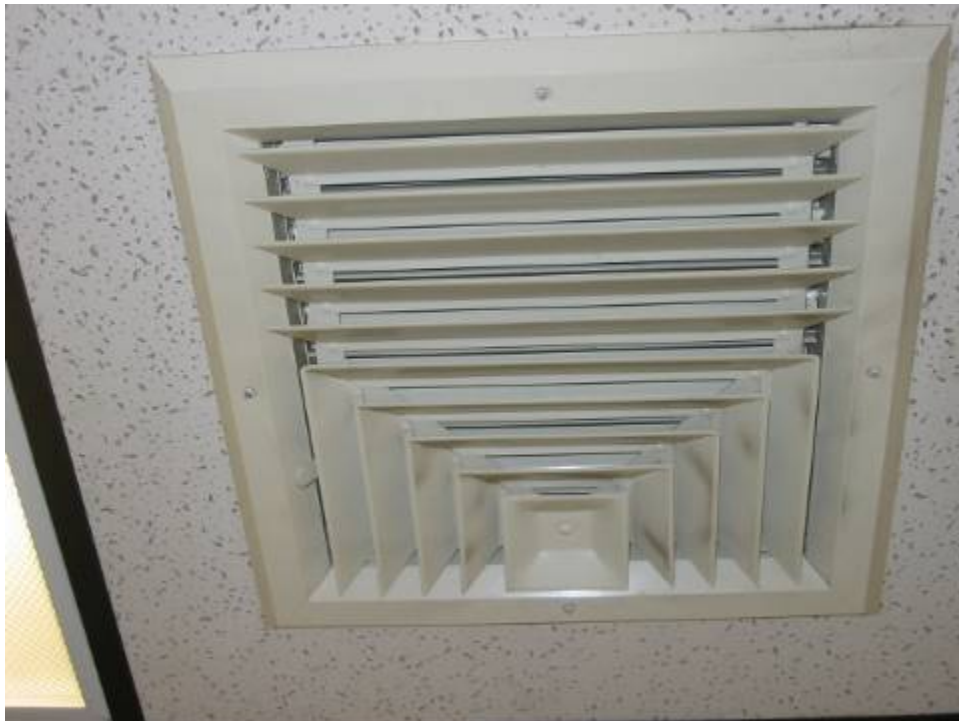
**Picture 10**

**Supply vent in modular building, which houses classrooms 31 to 34**

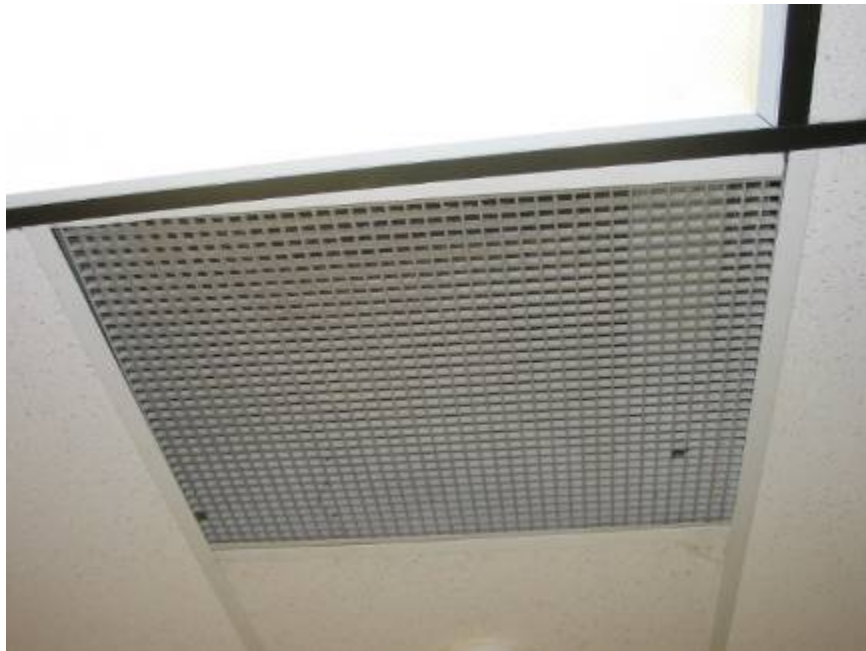
**Picture 11**

**Return vent in modular building, which houses classrooms 31 to 34**

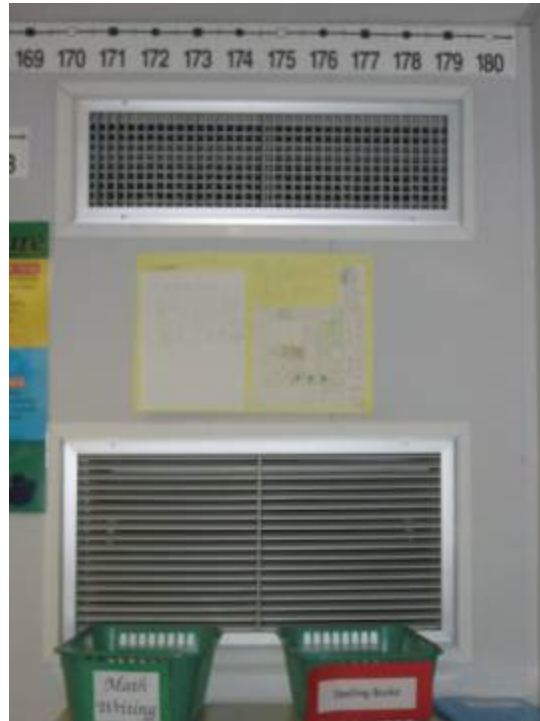
**Picture 12**

**Supply vent (top) and return vent (bottom) for modular building, which houses classrooms 41 to 44**

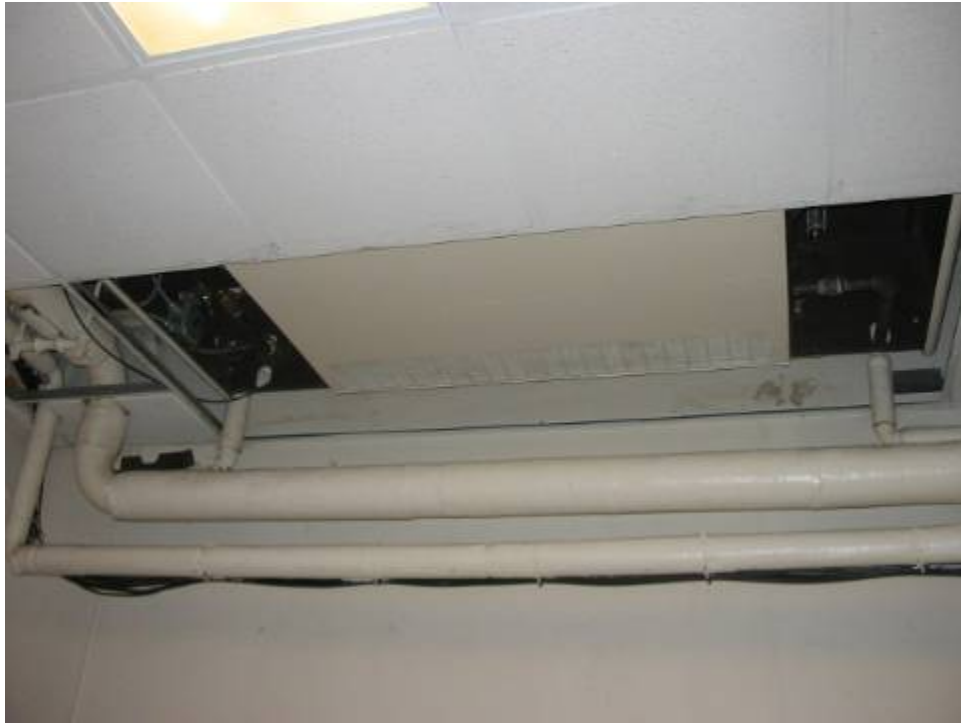
**Picture 13**

It appears that multiple rooms in the guidance/speech area near the cafeteria share a single univent. This ceiling-mounted univent (Picture 13) is ducted to ceiling-mounted diffusers. Passive vents were installed in shared walls to increase air flow between rooms. Consideration should be given to increasing the capacity of this univent to supply fresh air to these rooms. Consideration should also be given to increasing the size of the passive air vents between these areas to aid ventilation.

**Shared univert in guidance/speech area**

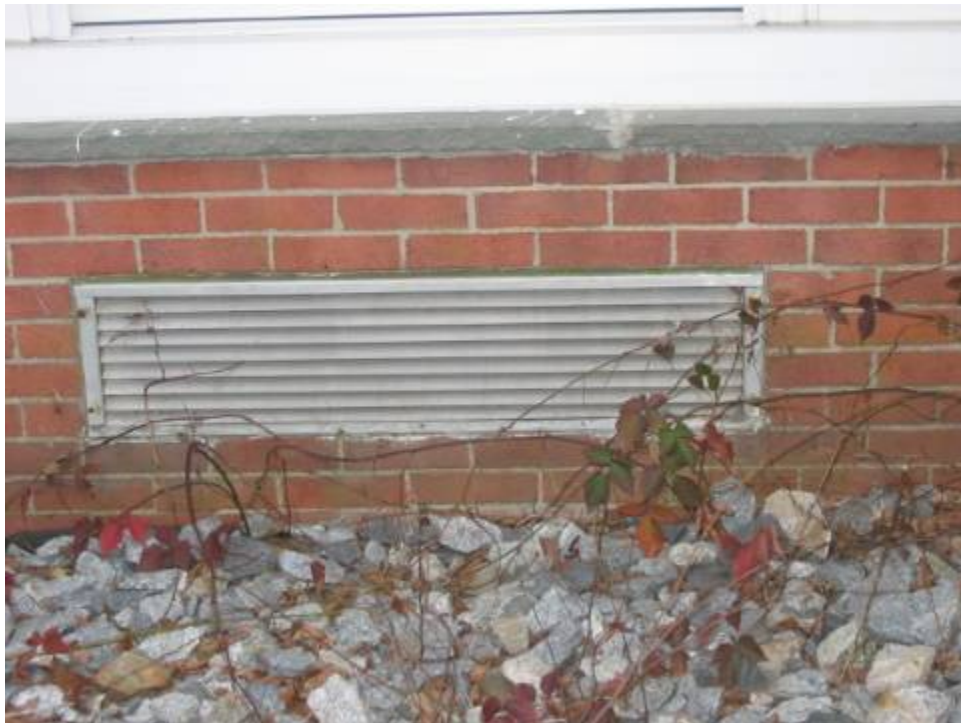
**Picture 14**

**Fresh air intake for classroom 4, note debris in front of intake**

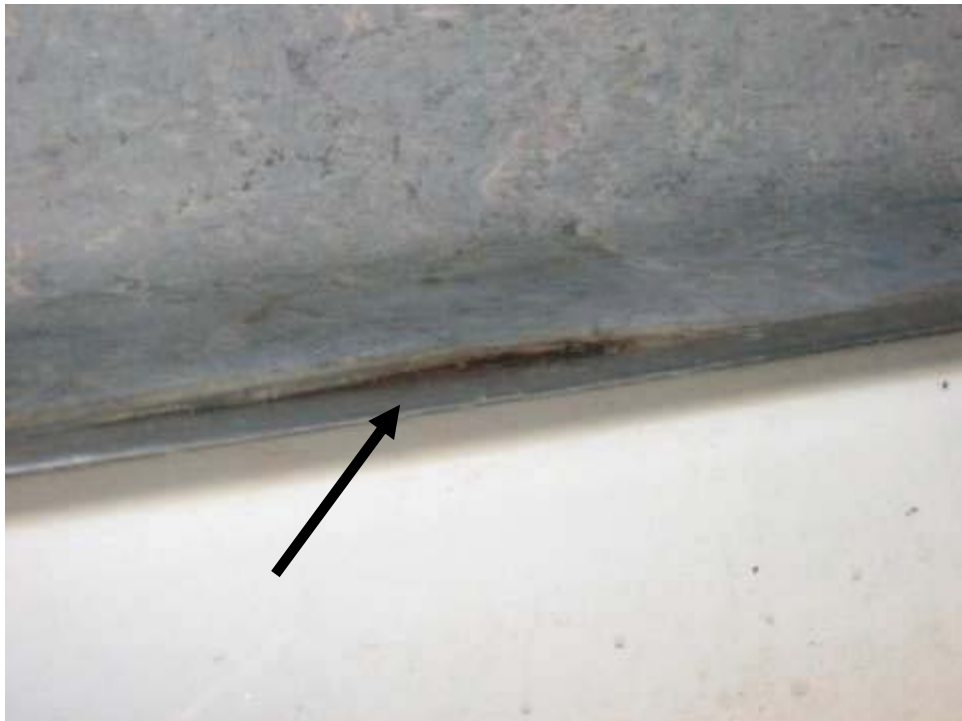
**Picture 15**

While mold growth was not observed in the building, some potential sources for mold growth were observed. Spaces between the sink countertop and backsplash were seen in several areas (Picture 15). Improper drainage or sink overflow can lead to water penetration into the

countertop, cabinet interior and areas behind cabinets. If these materials become wet repeatedly they can provide a medium for mold growth. The US Environmental Protection Agency (US EPA) and the American Conference of Governmental Industrial Hygienists (ACGIH) recommend that porous materials be dried with fans and heating within 24 to 48 hours of becoming wet (US EPA, 2001; ACGIH, 1989). If porous materials are not dried within this time frame, mold growth may occur.

**Breach between in sink countertop**

8. Seal breaches between sink countertops and backsplashes with an appropriate sealant to prevent water damage and potential mold growth.

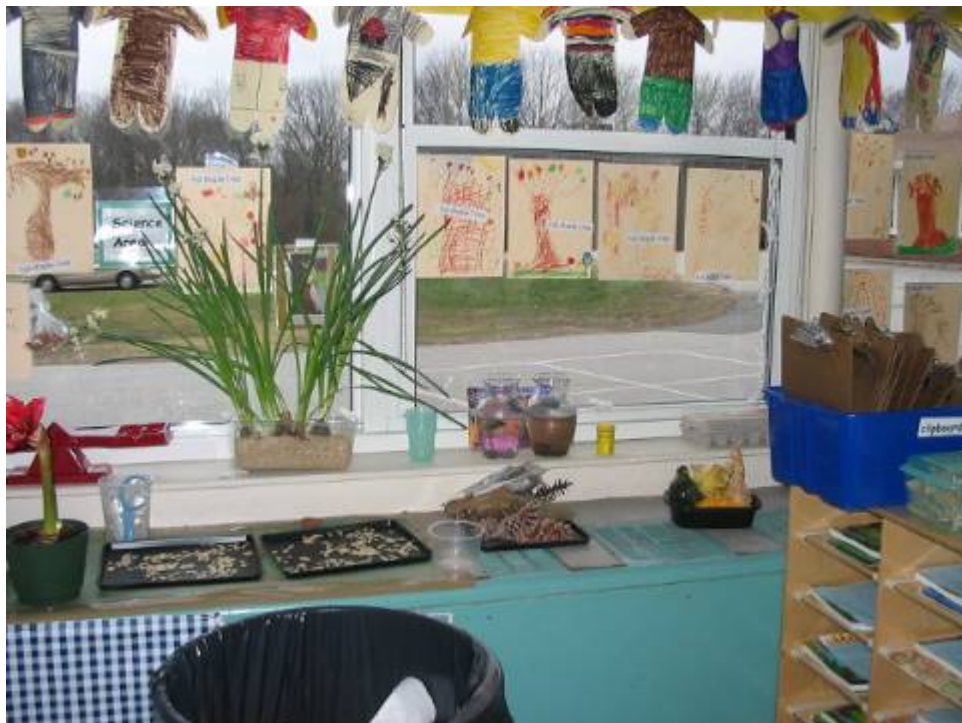
**Picture 16**

**Plant near univent, pine cones and expiring produce on univent fresh air intake**

9. Move plants away from univents in classrooms. Ensure all plants are equipped with drip pans. Examine drip pans for mold growth and disinfect areas of water leaks with an appropriate antimicrobial where necessary.

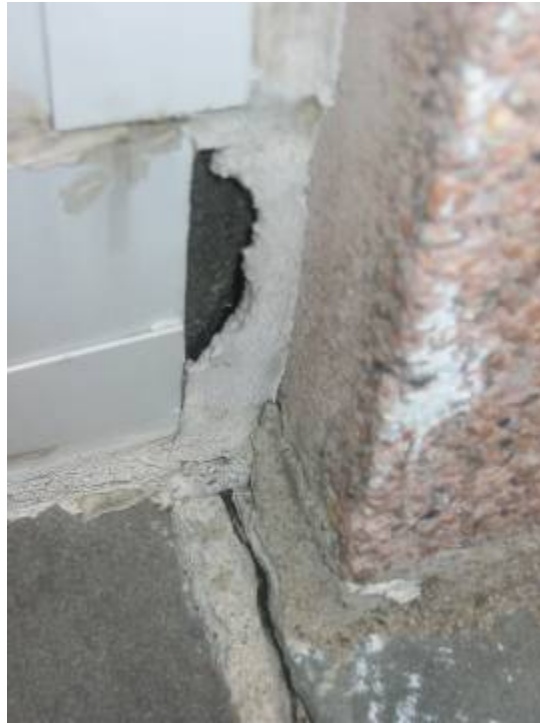
**Picture 17**

During an assessment of the exterior of the original building and 1960 addition, CEH staff observed damage to the foundation (Picture 17). Breaches, cracks and holes in the foundation can serve as points for water entry into the building. Continued freezing and thawing of water during cooler months will serve only to further damage the foundation. In addition, breaches can serve as points of entry or shelter for pests.

**Breaches in building exterior**

10. Repair damage to building foundation. Consider contacting a building envelope specialist for an evaluation of the building exterior.
11. Remove plant growth around the main building as well as around both modular buildings. Examine exterior of modular buildings to assess damage to the building envelope and make repairs where needed.

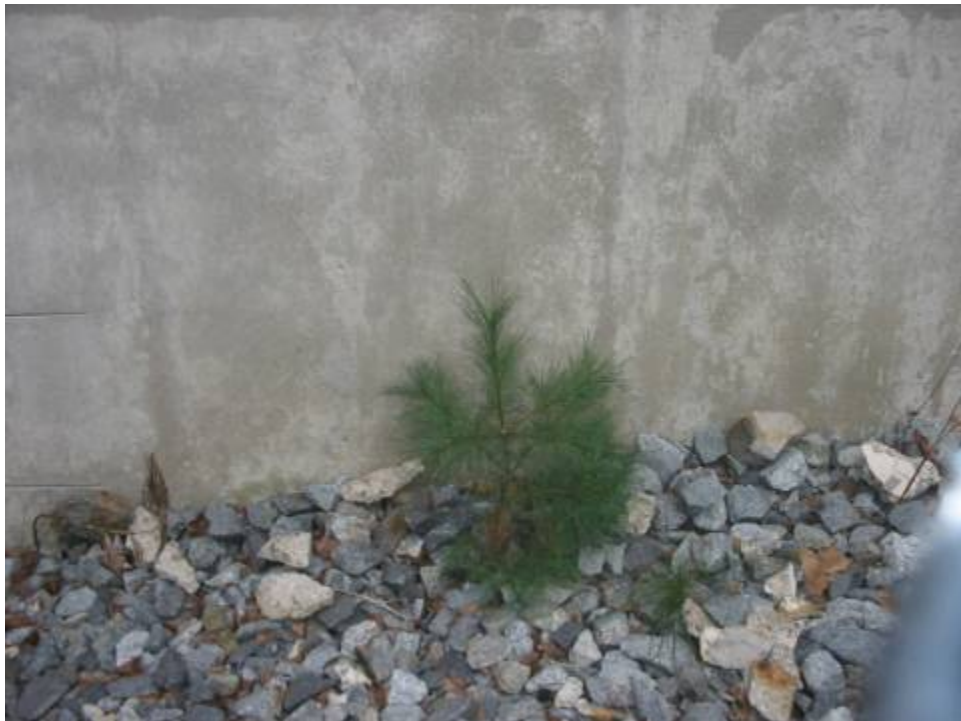
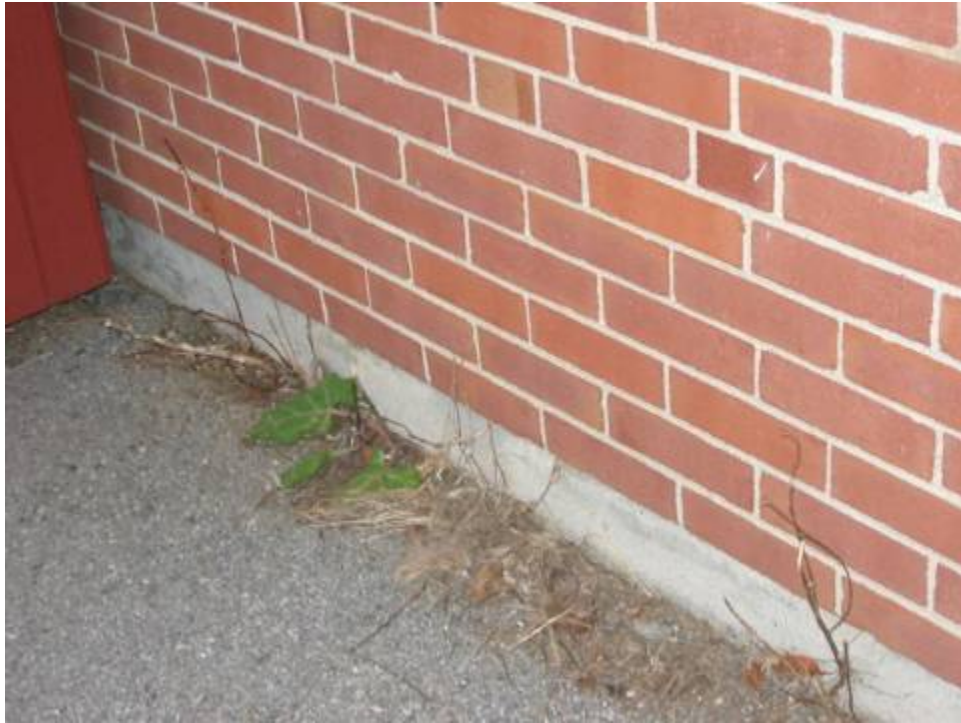
Small trees and other plants were also observed growing against the foundation (Pictures 18 and 19). The growth of roots against the exterior of foundation walls, as well as spaces

between the tarmac, can bring moisture in contact with brick and foundation, which may eventually lead to moisture penetration below ground level areas of the building.

**Sapling growing in close proximity to building**

**Plants growing against building foundation**

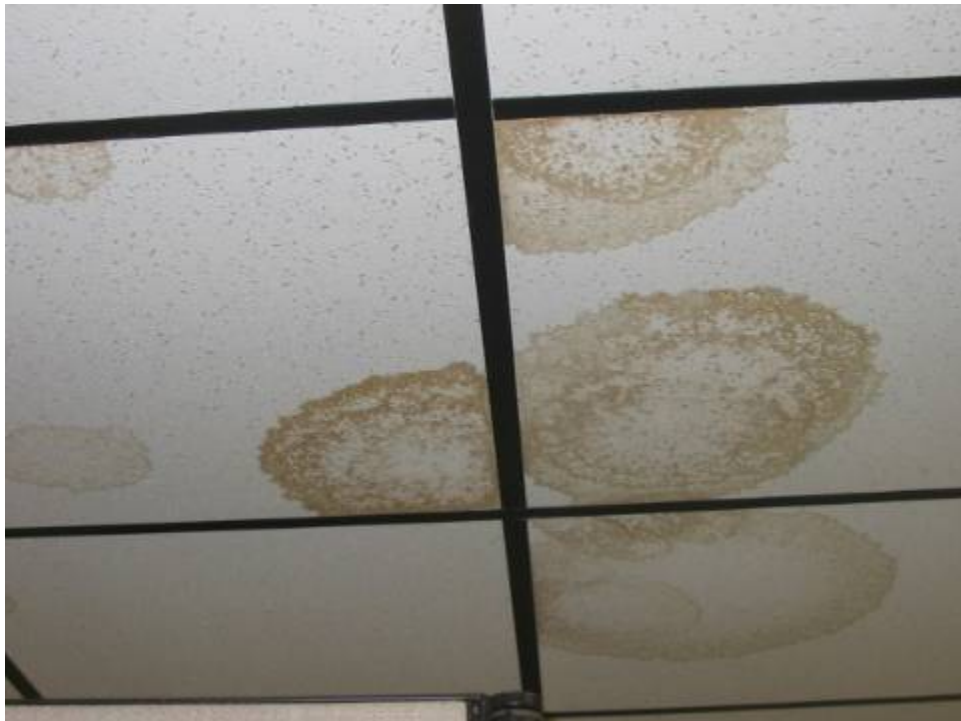
**Picture 20**

As previously discussed, two modular buildings of different ages were added to the HES. Upon entering the first modular building, which houses classrooms 31 to 34, CEH staff noted a slight musty odor. A number of water-damaged ceiling tiles were observed in these classrooms. Water-damaged ceiling tiles are typically an indication of roof or plumbing leaks (Picture 20). According to school personnel, this modular building has had a history of roof leaks. CEH staff examined the classrooms, but did not observe any additional water-damaged materials. However, a number of conditions concerning this modular building's exterior could serve as sources for moisture intrusion.

**Water-damaged ceiling tiles in older modular building**

16. Replace water-stained or missing ceiling tiles. Examine the area above and around these areas for mold growth. Disinfect areas of water leaks with an appropriate antimicrobial.

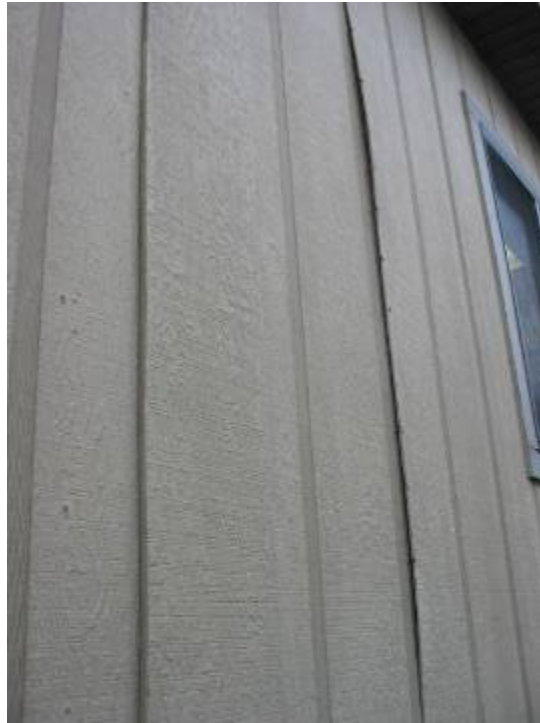
**Picture 21**

Many of the wood panels on the exterior of the modular unit were bowing and no longer attached to the building's frame (Picture 21). As a result, insulation is exposed to moisture (Picture 22). Insulation can act as a wick, drawing moisture towards the interior of the building, potentially moistening the interior wall. If moistened insulation is not dried, it can become a source for mold growth. At the time of the assessment, insulation appeared to be wet. However, no evidence of water damage was observed in the classrooms.

**Exterior wallboards no longer adhering to building frame**

12. Examine extent of damaged insulation on the exterior of the modular building and replace where necessary.
13. Repair breaches in the modular building envelope, including missing damaged siding, missing/damaged flashing, and spaces around windows and doors and roofs to prevent further water intrusion drafts and/or pest entry.

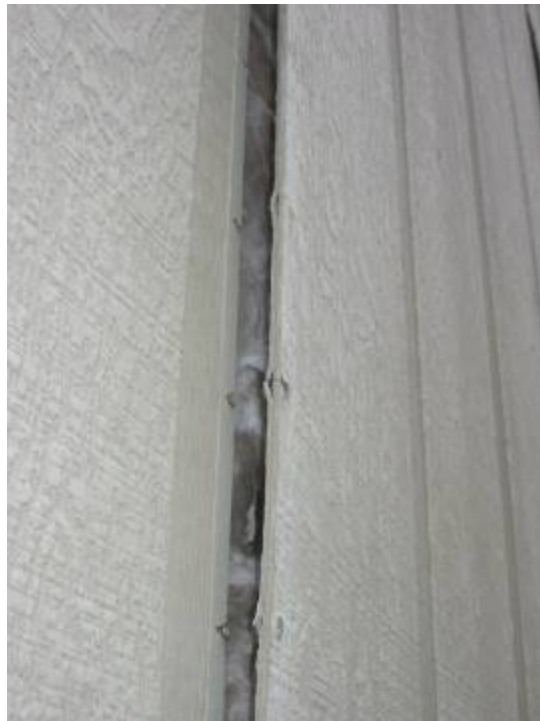
**Picture 22**

**Exposed insulation**

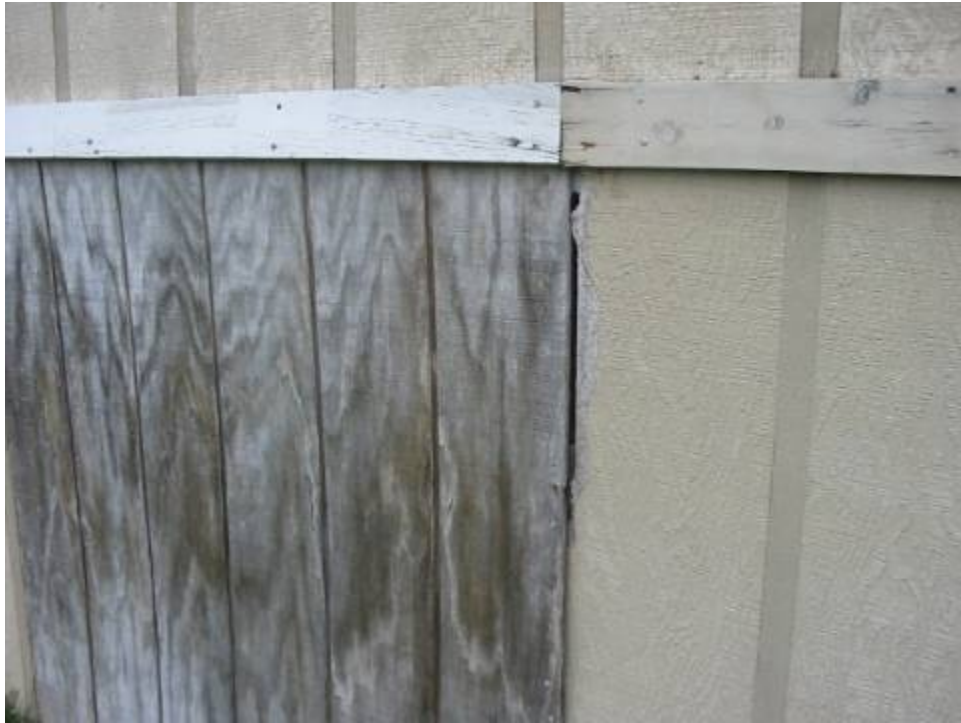
**Picture 23**

It appears that attempts were made to repair a previously damaged section of the enclosed crawlspace (Picture 23). However, CEH staff observed breaches in this area of the modular building. Holes, breaches, and seams are points through which water can penetrate the building, particularly under driving rain conditions.

**Breaches in crawlspace wall**

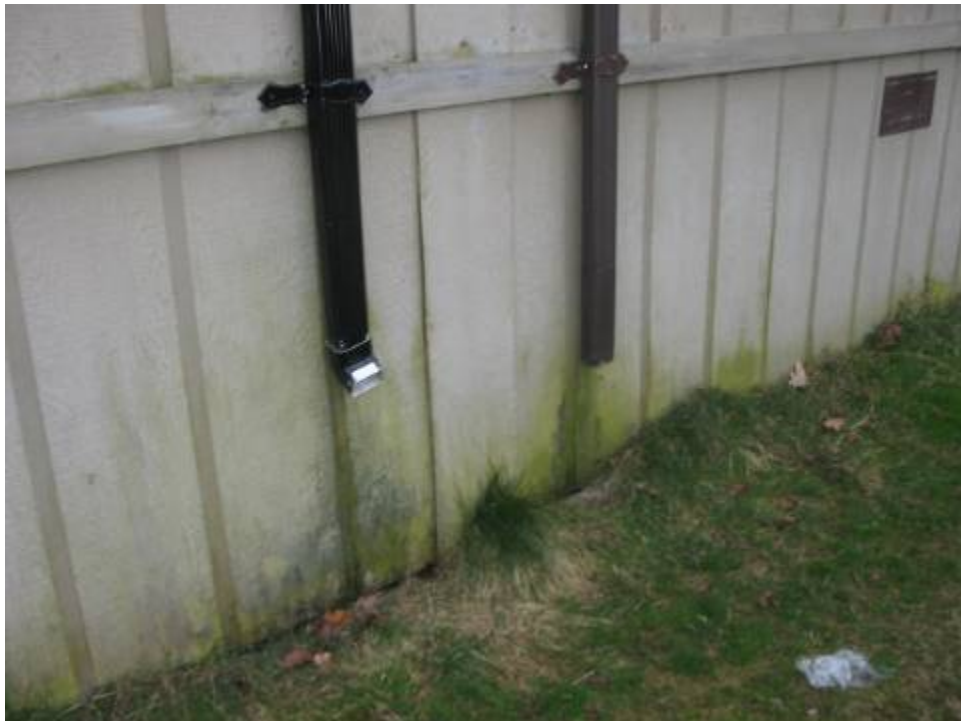
**Picture 24**

A number of downspouts were not configured in a manner that drains water away from the base of the modular building. Over time, repeated wetting of materials can cause damage, as evidenced by staining (Picture 24).

**Improperly installed downspouts**

14. Repair/replace existing gutters and downspouts that are damaged/missing.
15. Ensure the gutter/downspout systems to the modular buildings are draining properly to prevent leaks and water accumulation against the buildings. Examine the roof membrane to ensure it is intact.

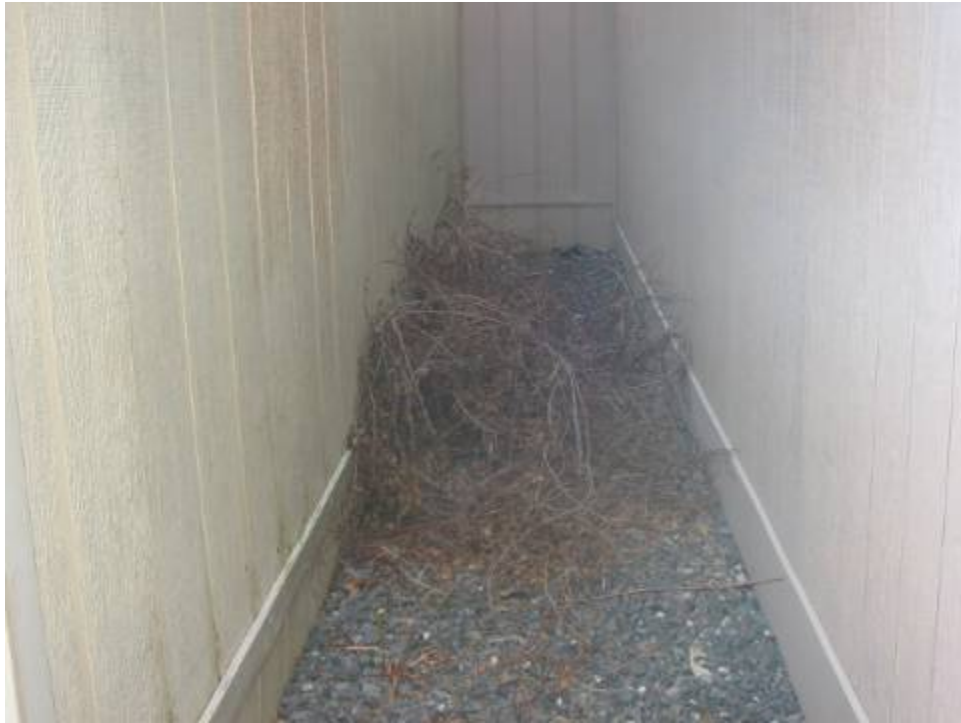
**Picture 25**

Plant growth was observed growing against the crawlspace/base of the modular buildings (Picture 25), indicating that the area below is retaining moisture and nutrients. The growth of plants against the exterior walls of a building can bring moisture in contact with building materials causing water damage and subsequent microbial growth.

**Thorny weeds growing against modular buildings**

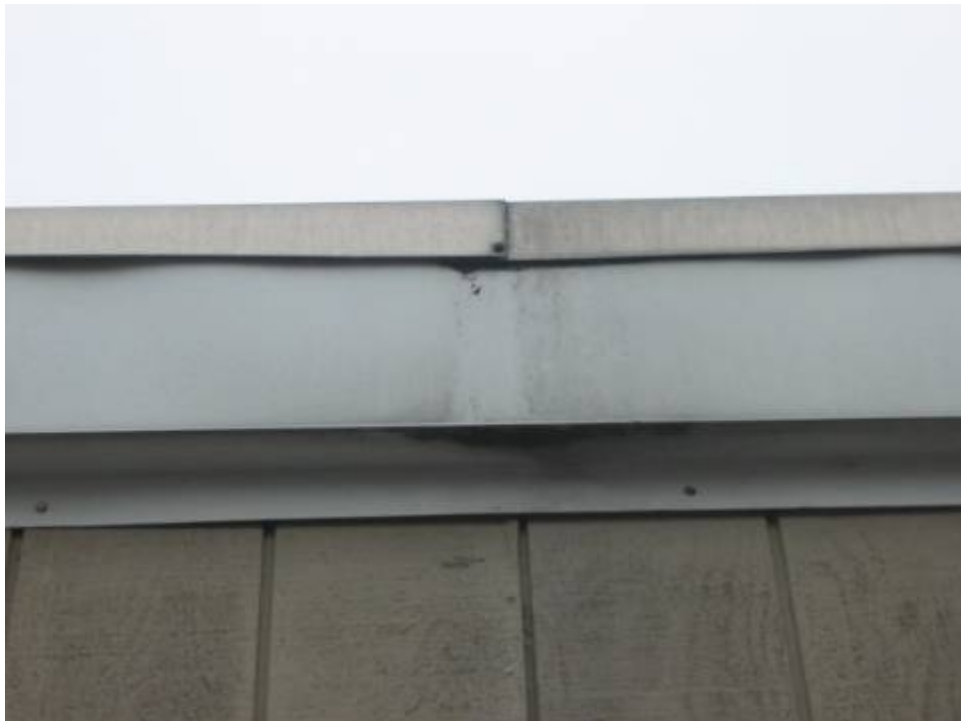
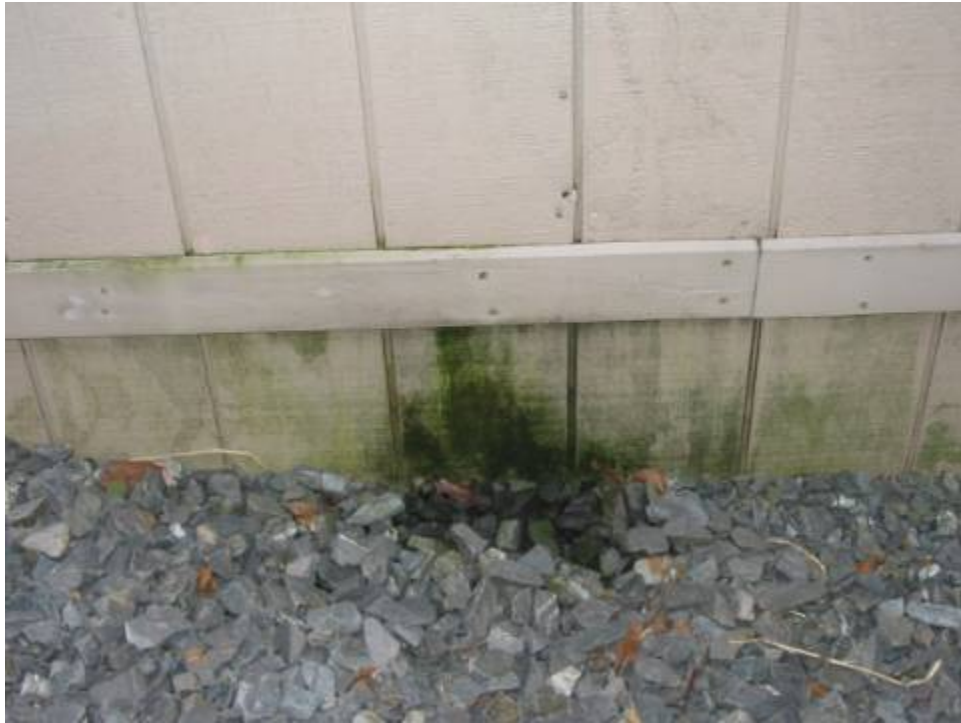
No odors were detected in the modular building housing classrooms 41 to 44; however, some moisture related issues were observed. Plant growth was observed growing into AHUs. In addition to the potential for damaging the building envelope, such growth can also damage motors and other mechanical components of the HVAC system. Furthermore, damaged flashing along the side of the building was causing water damage to the crawlspace enclosure (Pictures 26 and 27).

**Damaged flashing on newer modular building**

**Area below damaged flashing depicted in Picture 26**

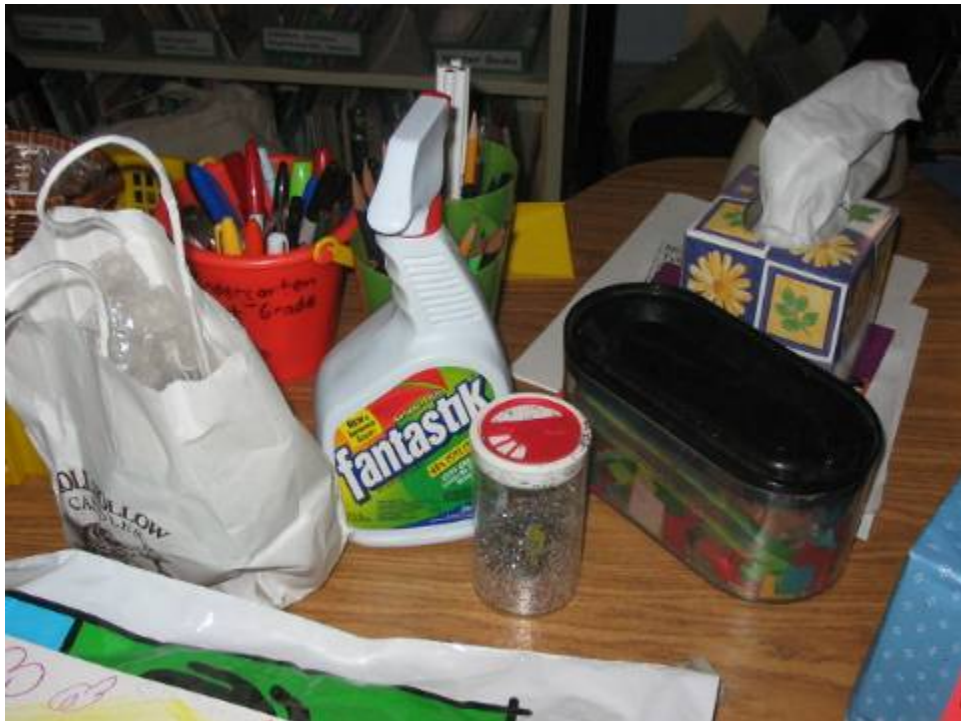
**Picture 28**

Cleaning products were found on tables, countertops and beneath sinks in a number of classrooms (Picture 28). Cleaning products contain VOCs and other chemicals, which can be irritating to the eyes, nose and throat and should be stored properly and kept out of reach of students. Consideration should be given to storing products in cabinets inaccessible to children. If cleaning products are stored in lower cabinets, consider using childproof locks on cabinet doors.

**Cleaners on table**

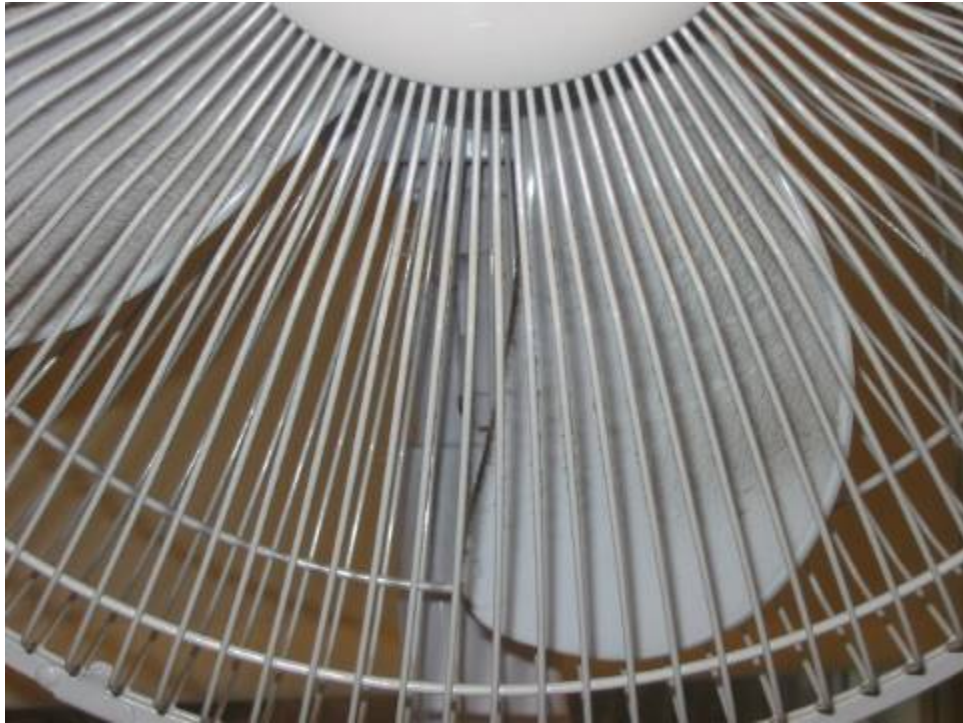
**Picture 29**

A number of exhaust/return vents, univent supply vents and personal fans were observed to have accumulated dust. If exhaust vents are not functioning, backdrafting can occur, which can re-aerosolize accumulated dust particles. Re-activated univents and fans can also aerosolize dust accumulated on vents/fan blades (Picture 29).

**Dust accumulation of personal fan**

20. Clean univent air diffusers, fan blades and exhaust vents periodically of accumulated dust.
21. Clean filters for window-mounted air conditioners as per manufacturer's recommendation.

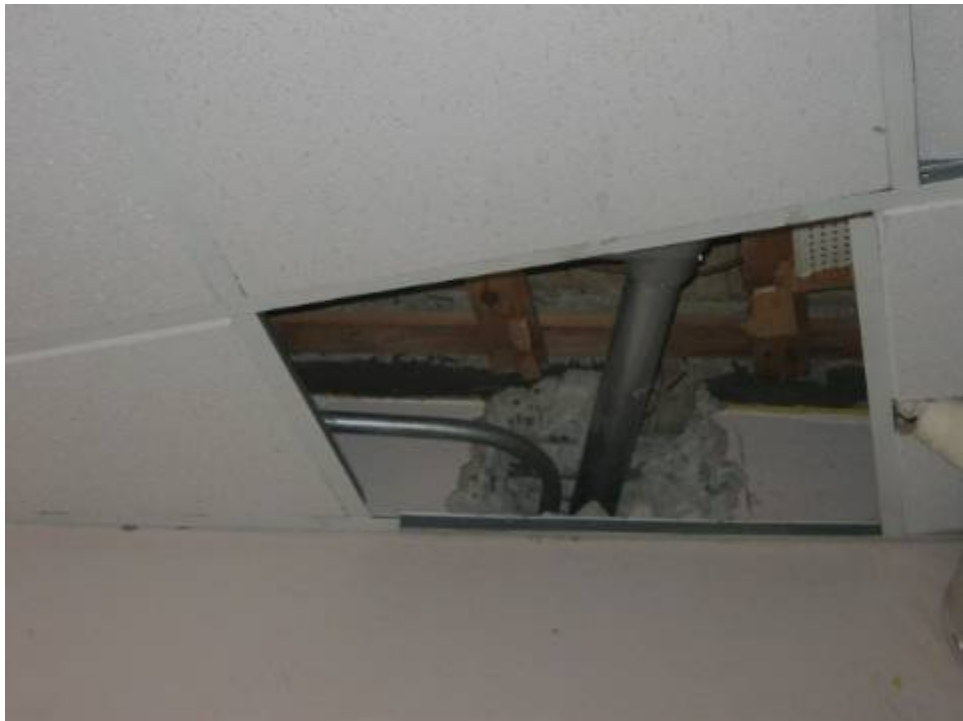
**Picture 30**

Missing and ajar ceiling tiles were observed in a number of areas, primarily in the guidance/speech area (Picture 30). Missing/ajar ceiling tiles can provide a pathway for materials (e.g., odors, dust, particulates) to move from unoccupied areas to occupied areas. Ceiling tiles should be flush with the ceiling system to prevent such movement. Similarly, utility holes and breaches should be sealed to prevent movement of materials.

**Missing ceiling tile**

23. Replace missing ceiling tiles, and ensure all ceiling tiles are flush with suspended system.
24. Seal utility holes and breaches to prevent movement of materials to occupied areas.
